Osseointegrated Brånemark Implants Used To Retreat a Fractured Mandibular Bone Plate Staple Implant: A Case Report

Thomas J. Balshi, DDS

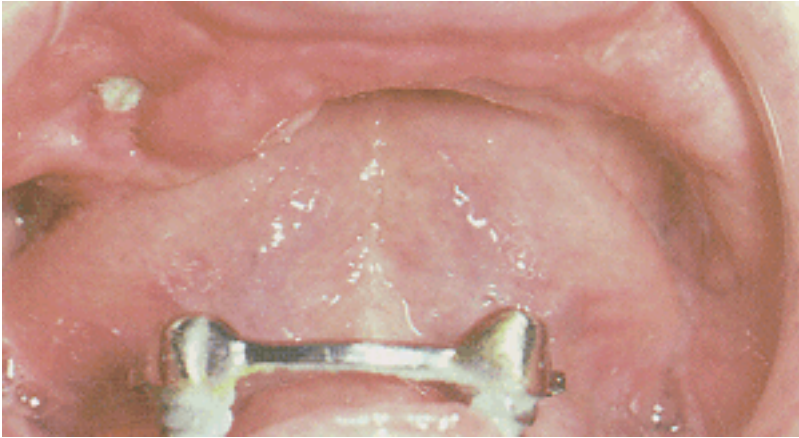
Fig. 1 Maxilla: 7 weeks following iliac crest onlay bone graft; note dehiscence in right ridge area. Mandible: Bone plate staple implant with Ceka attachments and center clipbar support for a removable overdenture.

The patient's dental condition involved a maxillary fixed tissue-integrated prosthesis supported by five Brånemark fixtures. An iliac crest onlay bone graft, using implants for stabilization, was allowed to heal for 10 months before fixed prosthesis treatment began (Fig 1).

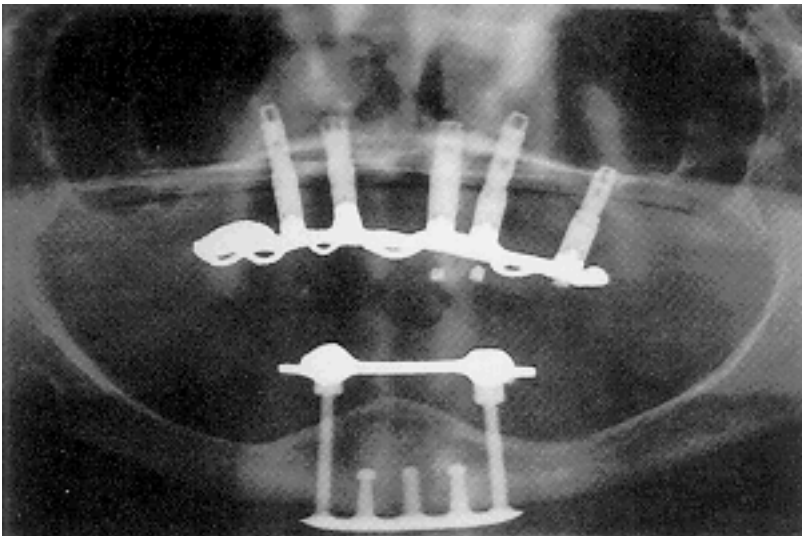
When the patient presented for examination, a discrepancy in the casting fit of

the maxillary prosthesis was noted (Figs 2a and 2b). The treatment plan provided for the fabrication of an accurately fitting casting to support an esthetically and phonetically acceptable fixed tissue-integrated prosthesis. In the mandible a removable overdenture was stabilized by Ceka attachments (Ceka NV, Antwerp, Belgium), and a gold clip bar was cemented to the transmucosal posts of a bone plate staple implant. The initial treatment plan provided for the readaptation of the precision attachment overdenture.

Fig. 2a Pretreatment panoramic radiograph illustrates mandibular bone plate staple implant with a gold clip bar and maxillary tissue-integrated prosthesis. Treatment completed 6 months earlier.

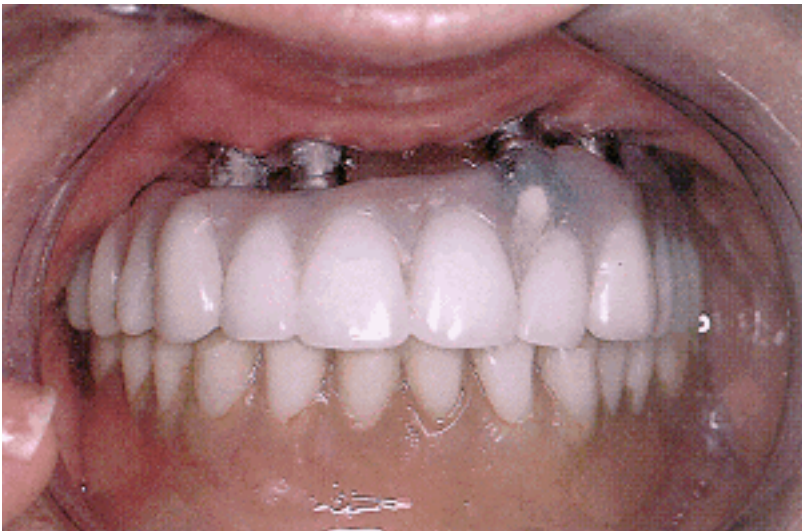
Fig. 2b Unacceptable esthetics and phonetic position of teeth.

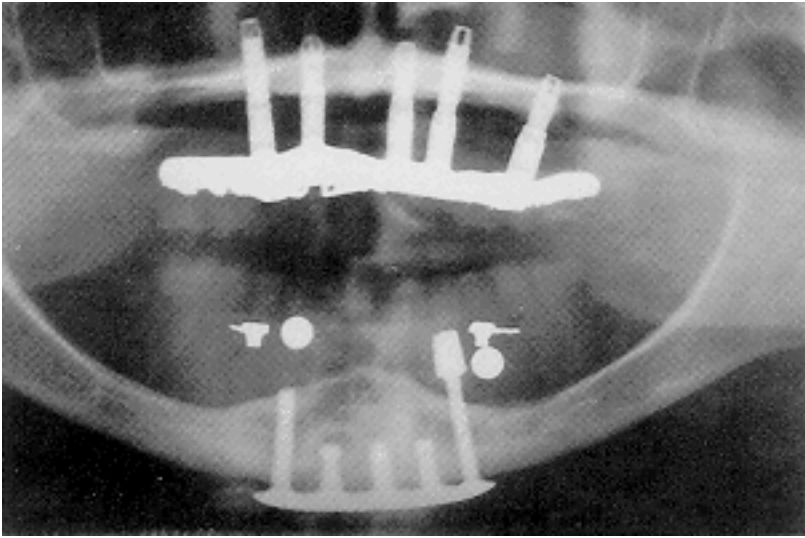
Following completion of prosthodontic treatment in the maxilla and mandible, the patient returned with a fracture of the left transmucosal pin of the mandibular bone plate staple implant (Fig 3). A new treatment plan was designed. It involved the use of Brånemark fixtures between the vertical posts of the staple implant to support a fixed prosthesis. Specially designed narrow-diameter (3.0 mm) fixtures were used between the interior staple pins. The right inferior alveolar canal was uncovered and the neurovascular bundle was repositioned buccally, permitting the placement of two fixtures distal to the right transmucosal pin (Fig 4). Healing occurred with no loss of feeling in the lip and minimal postoperative discomfort.

Fig. 3 Panoramic radiograph illustrating completed maxillary tissue-integrated prosthesis and fractured transmucosal pin of bone plate staple implant.

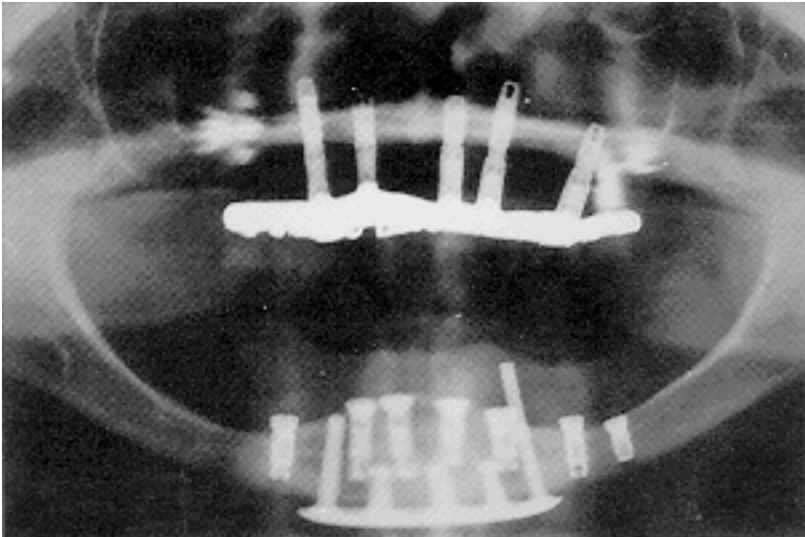
Fig. 4 Specially designed 3.0-mm-diameter fixtures placed between the interior pins of the staple implant. Note that right posterior fixtures use all available bone of the severely resorbed posterior mandible following the repositioning of the neurovascular bundle.

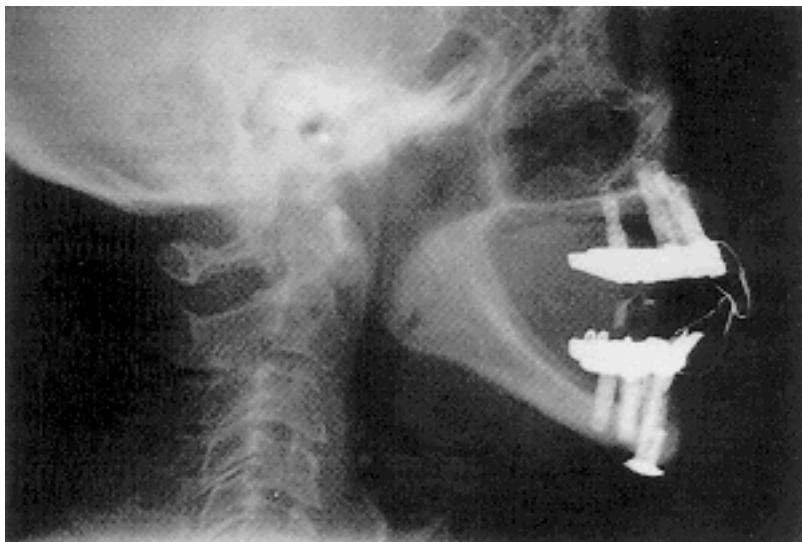
Fig. 5 Postoperative lateral cephalometric radiograph: Remains of failed staple implant beneath completed fixed tissue-integrated prosthesis.

After 3 months, the fixtures were exposed and the right transmucosal pin of the staple was cut at bone level. Titanium abutments were attached to the Brånemark implants, and a fixed tissue-integrated prosthesis was placed 1 week later during suture removal (Fig 5).
