Retreatment: Fractured Implants Due To Biomechanical Overload

Glenn J. Wolfinger,
DMD, FACP

Thomas J. Balshi,
DDS, FACP

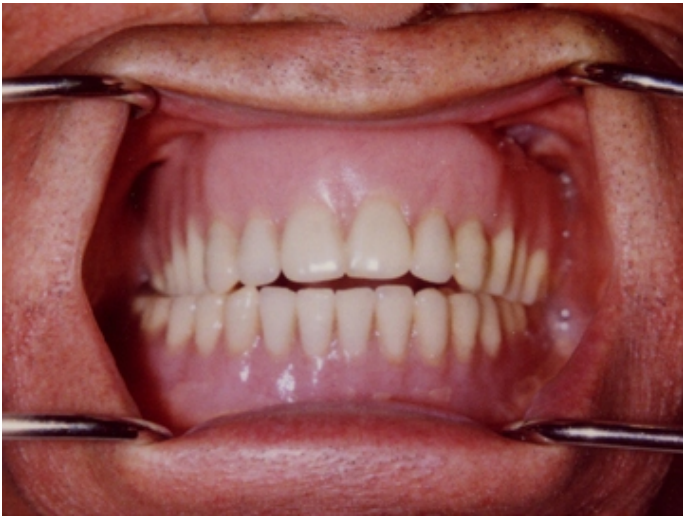
*Fig 1
Protruded mandibular Prosthesis with no retention*

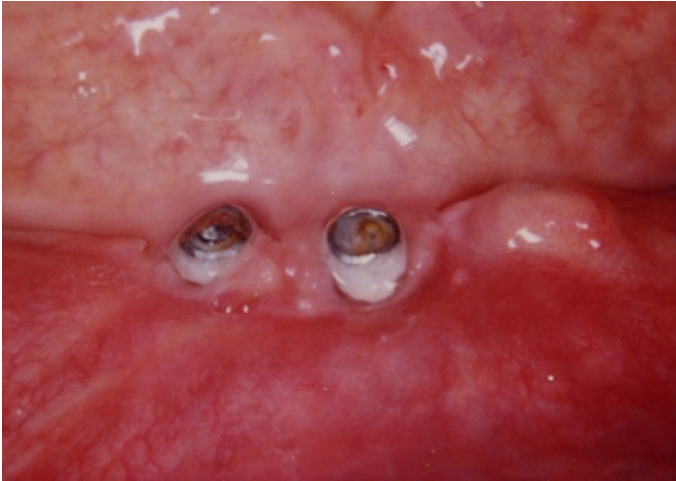
*Fig. 2
Clinical View of Fractured Implants*

Six years prior to our initial examination, a dental colleague and friend of the patient placed three press fit cylinder implants in the greatest bone volume of the anterior mandible to function as retentive support for an overdenture. All three implants osseointegrated; however, the extreme mechanical overload eventually led to their fracture (Fig 2). At the time of our examination, the mucosal tissue surrounding the fractured implants was highly inflamed, hyperplastic and painful.

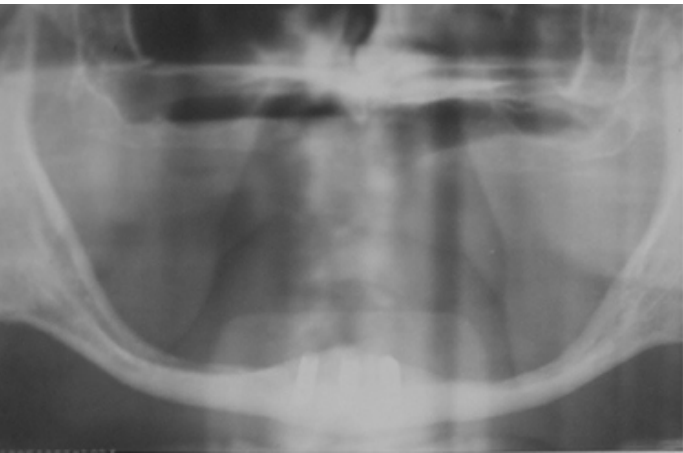
*Fig. 3 Panorex radiograph at Initial Exam
with 3 fractured implants*

Radiographic evaluation was accomplished with panradiographs (Fig 3), lateral cephalometric films (Fig 4) and anterior-posterior cephalometric films (Fig 5). The three fractured

implants visible on these radiographs used only half the available vertical height of bone in the symphysis area. The severe atrophy of the body of the mandible, especially in the area of the mental foramina, ranged from 5 to 8 mm in height. The inferior alveolar canal was partially deteriorated due to advanced atrophy of the alveolus, exposing the neurovascular bundle on the crest of the alveolar ridge.

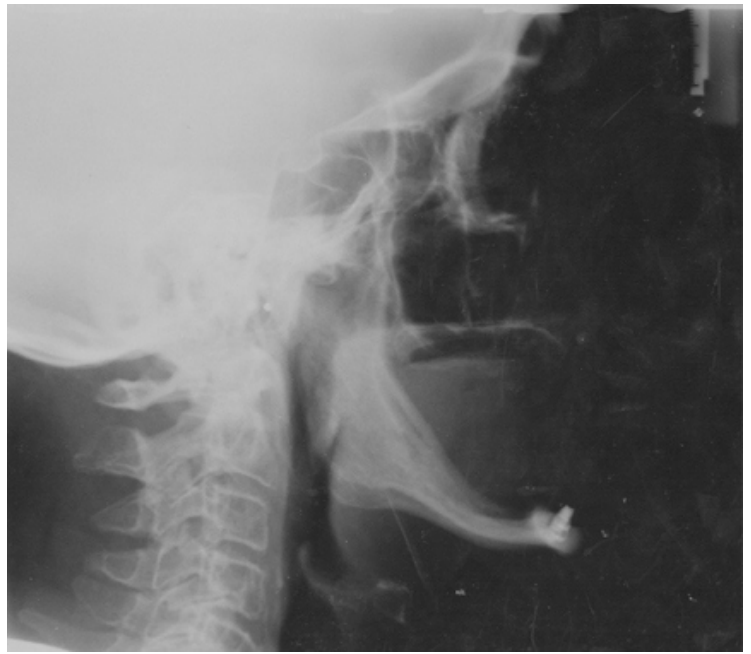
*Fig 4 Pretreatment Lateral Cephalometric Radiograph
showing fractured implants in extremely thin bone*

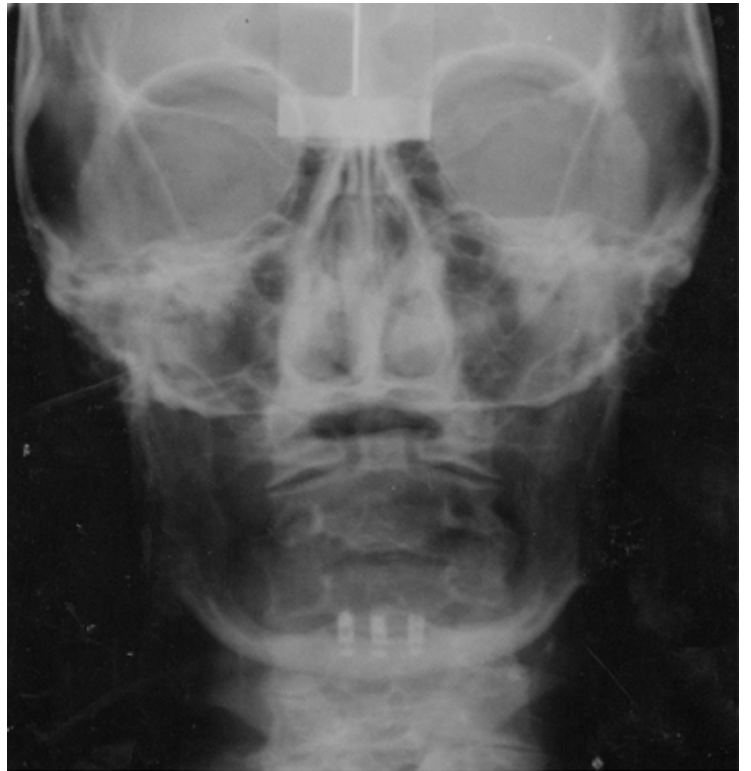
*Fig 5 Pretreatment A-P Cephalometric
radiograph with fractured implants evident*

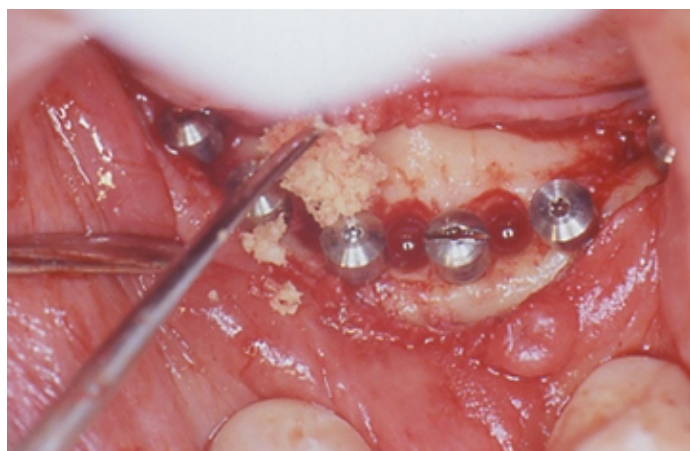
Fig 6
Soft tissue debridement around fractured implants.

Inflamed and hyperplastic tissue was debrided from around the fractured implants (Fig 6). Using a trephine drill (Fig 7) and copious sterile saline irrigation, bone was removed from the area immediately around the three fractured implants. The thickness of the

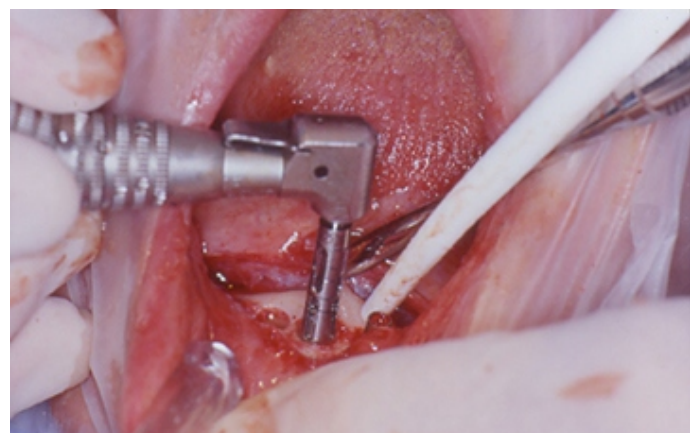
Fig 7
Trephine removes bone around fractured implants.

trephine was 0.75mm, removing a minimal amount of bone. All bone “dust” was collected for future autogenous grafting if required. The trephine was taken to the depth just short of the implant apex. Elevators (Fig 8) and extraction forceps were used to loosen and remove the implants. Dense cortical bone was noted at the apex of the implant socket (Fig 9).

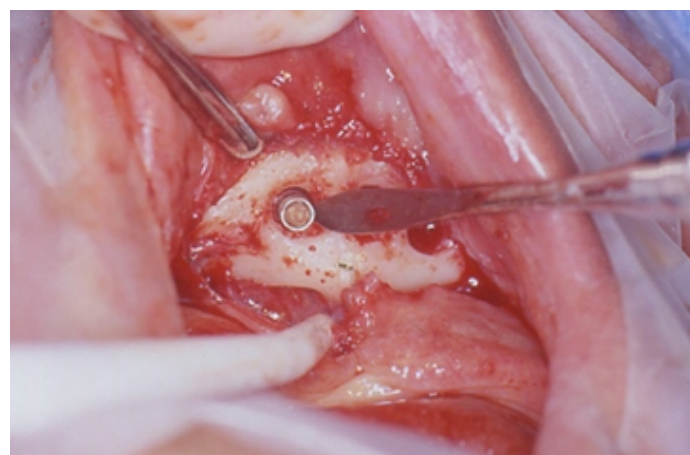
Fig 8
Loosening and removal of fractured implants.

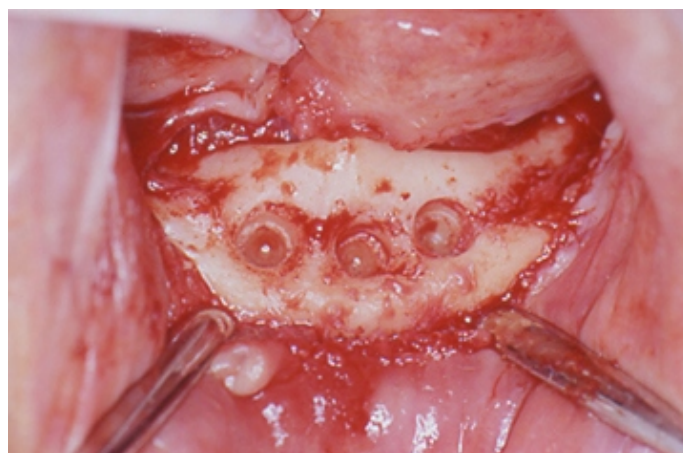
Fig 9
Dense cortical bone exposed at apex of implant site.

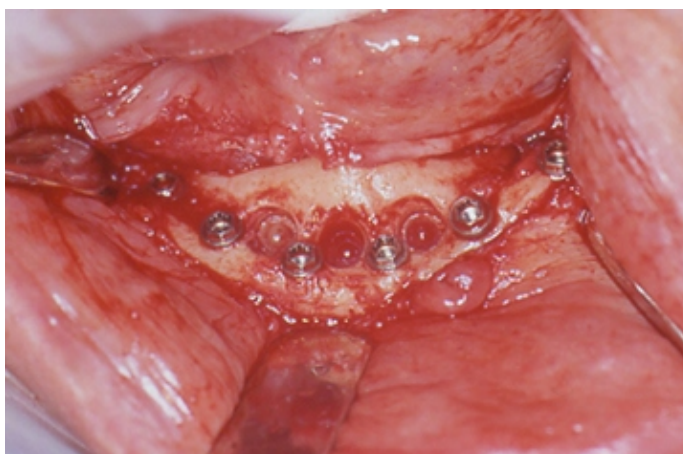
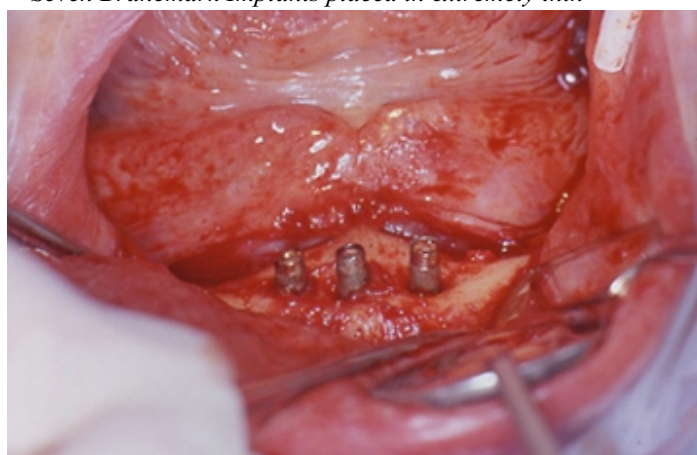
Fig 10
Seven Brånemark Implants placed in extremely thin mandible.

Seven implant sites were selected based on the biomechanical principle of broad load distribution. These sites were uniformly distributed from the area of the first molars bilaterally. The implant osteotomies were prepared using a series of graduated sized drills. The threads were then tapped through the inferior border of the mandible to accommodate the Brånemark implants. Seven 3.75 mm diameter implants of three lengths were placed: one 7mm, two 8.5mm and four 10mm (Fig 10). Autogenous bone gathered from the implant sites was placed in the area of the three fractured implants that were removed (Fig 11). Titanium healing abutments were placed on all implants and the mucosal flaps were irrigated with a tetracycline solution prior to closing with vicryl sutures.

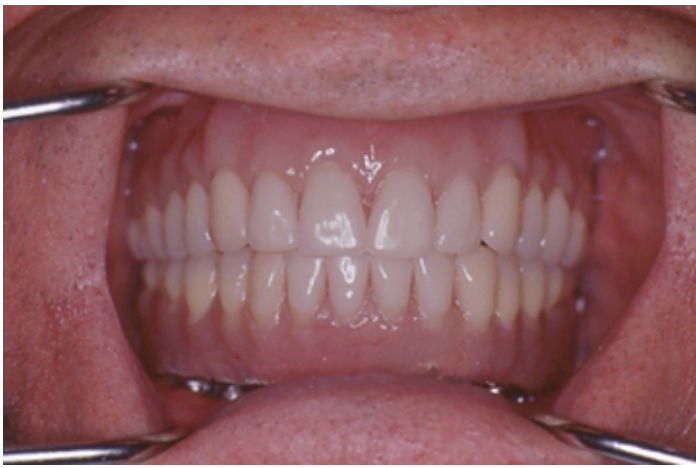
*Fig. 12 Stage II -
Estheticone and Standard Abutments placed on implants*

Following an extended healing period of six months (three months is considered adequate healing for the anterior mandible) the healing abutments were removed and a combination of five standard and two EsthetiCone abutments were fastened to the osseointegrated implants (Fig 12). A conversion prosthesis was constructed at the previously determined vertical dimension using the interim denture. This prosthesis was then transferred to the master cast for articulation. Two additional visits for a casting try in and delivery of the final prosthesis (Fig 13, 14) completed the doctor's treatment.

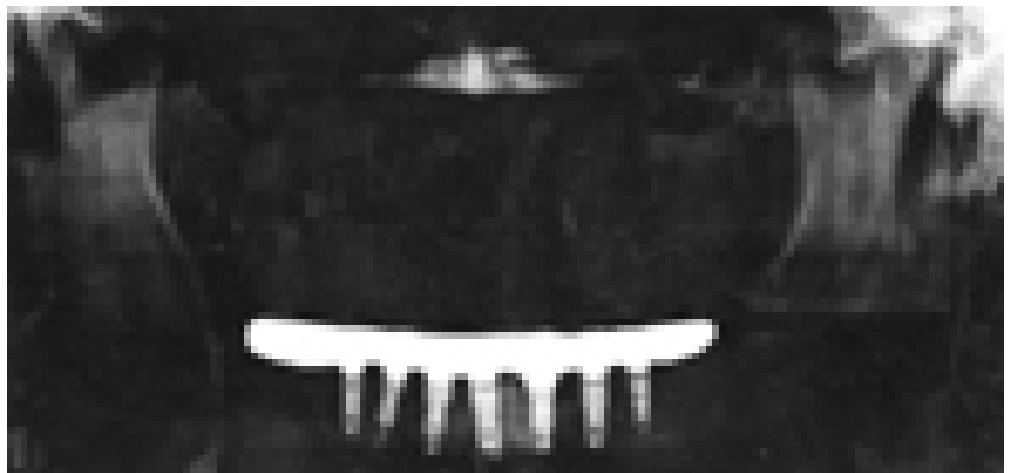
Fig. 16
Post-op panoramic radiograph
