### Catastrophic implant failure after immediate loading of full arch implant prosthesis and its association with CPAP therapy: A case report

Julio J. Rodriguez DDS, MS<sup>1</sup> | Alexis Gertler DDS<sup>2</sup> | John Bender DMD<sup>2</sup> | Neeraj Surathu BDS<sup>2</sup> | Thomas J. Balshi DDS, FACP, PhD<sup>3</sup>

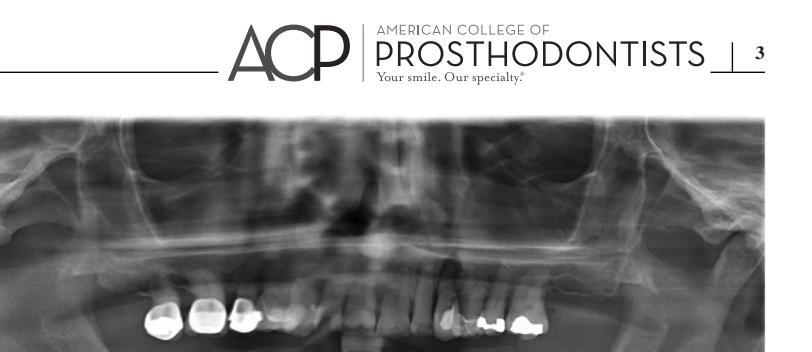
**FIGURE 1** Initial surgery post-operative panoramic radiographic.

- 1. Angulated posterior implants were placed in an effort to increase AP spread (Figure 1).
- 2. Multiunit abutments were placed on implants to correct angle and torqued to 25 Ncm. Temporary cylinders were hand-tightened onto abutments. A removable denture was used as a conversion prosthesis on temporary cylinders. Approximately 5 mm diameter preparation holes were made to accommodate temporary cylinders. Temporary cylinders were picked up under rubber dam isolation with polymethlymethacrylate (PMMA).

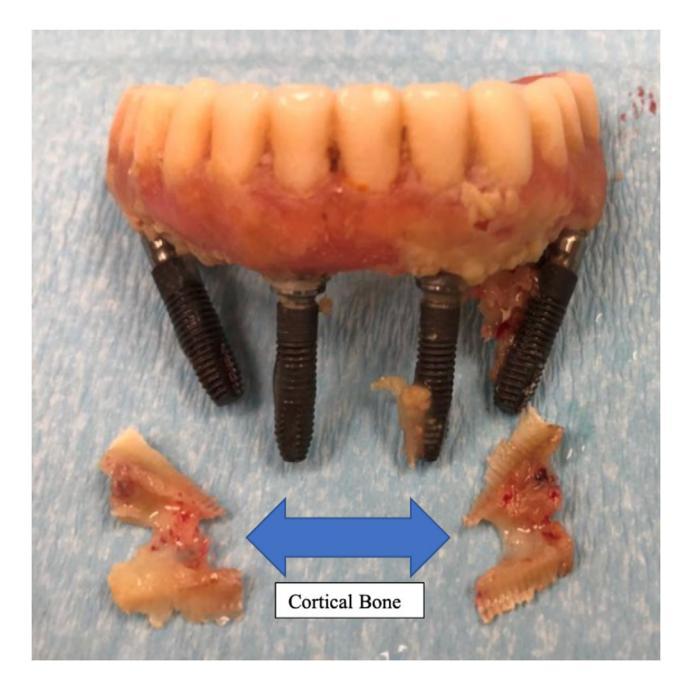
FIGURE 2 Removal of failed All on four prostheses with implants.

During this visit, the flaps appeared to be reopened, exposing a significant amount of bone. The conversion prosthesis was carefully removed in order to access the implants and surrounding bone. When removing the seals from the screw access channels, the entire prosthesis was mobile and was easily removed out of the mandible including all Astra Tech EV implants. Significant facial and lingual cortical plates remained attached to the implants as the entire prosthesis was removed (Figure 2).

With the implants removed, all granulation tissue and necrotic bone were thoroughly excavated. Remaining bone was scrapped to cause bleeding indicating vital bone with potential of new bone formation. Chlorohexidine solution was used to irrigate the surgical site.

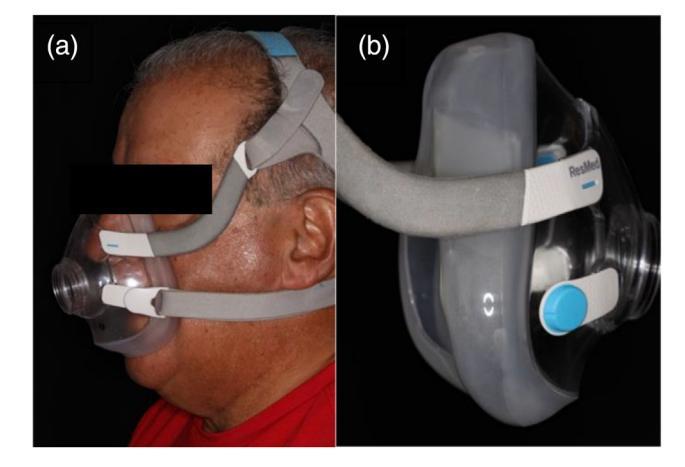
of the immediate load conversion prosthesis. This is a landmark article that will add CPAP equipment use to the list of osseointegration risk factors. The authors predict CPAP use is a high-risk contributing factor for implant failure due to the following reasons: mechanical pressure exerted by the mask margin on the mucosal flap closure, positive air pressure on the bone, and bacteria forced under the mucosal flaps from the CPAP tube.

**FIGURE 3** (a) Sagittal view of the patient wearing CPAP mask; (b) CPAP mask.

patient was using the CPAP with pressure, he was advised to not use said CPAP face mask device for the following 3 weeks (Figure 3). The patient's sleep physician approved this and recommended different sleeping positions that would help the patient with the chronic sleep apnea. The physician recommended elevating the head of the bed 3–4 inches.

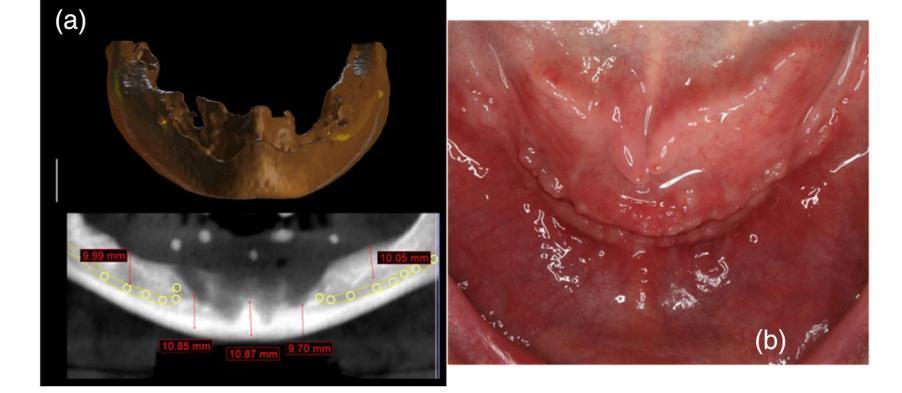
Patient presented 3 weeks later for suture removal and reevaluation of the existing bone. Mucosal soft tissue was well healed. A CBCT was taken to evaluate bone availability to plan the new implant placement (Figure 4).

**FIGURE 4** (a) CBCT assessment and (b) Intraoral view (post full arch implant extraction).

Revision implant surgery was planned in Nobel BioCare DTX studio dental software (Nobel Biocare, Yorba Linda, California) based on the bone remaining and bone available. Branemark NobelSpeedy Groovy external hex design implants were chosen for the revision surgery. These new implants are different than the failed Astra EV Osseospeed implants that were originally placed.

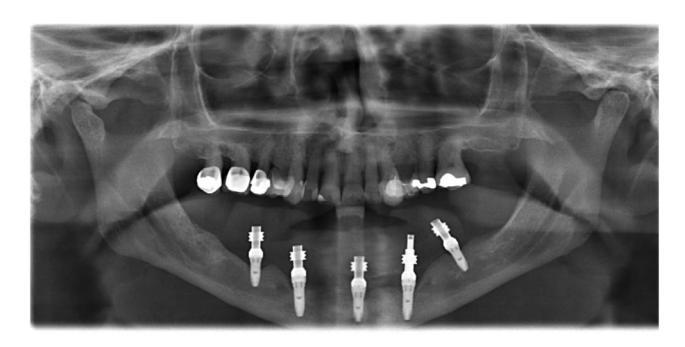
**FIGURE 5** Revision surgery, post-operative osseointegration panoramic radiographic.

- Site #24 4.0 × 10 mm Nobel Branemark Speedy Groovy with 45 Ncm insertion torque and Osstell was used to measure Implant stability quotient (ISQ) 53/57.
- Site #27 4.0 × 11.5 mm Nobel Branemark Speedy Groovy with 50 Ncm insertion torque and Osstell was used to measure ISQ 59/60.
- Site #22 4.0 × 10 mm Nobel Branemark Speedy Groovy with 30 Ncm insertion torque and Osstell was used to measure ISQ 52/54.
- Straight 3 mm collar height multiunit abutments were placed on the implant #24,27, and cover screw was placed in the implant #22.

Three weeks later the patient returned for implant surgery in the anterior mandible. The patient was premedicated with 600 mg Clindamycin. After infiltration of local anesthetic in the anterior of the mandible, a crestal incision was made in the middle of the ridge and two vertical releasing incisions were created in areas #20 and #29. A full thickness flap was elevated beyond the mucogingival junction so that mental foramens could be identified. Implant osteotomy was done using Nobel Speedy External hex surgical kit. The following implants were placed (Figure 5):

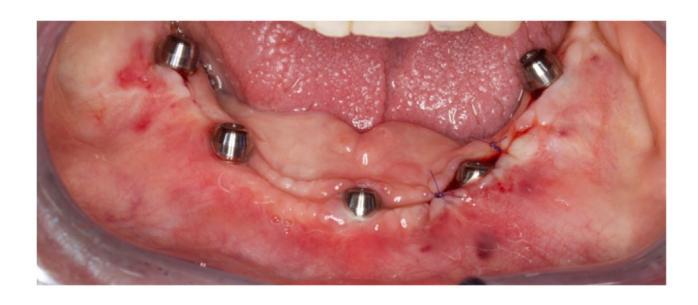
FIGURE 6 Intraoral view of healing mandibular arch.

Eight weeks after the last surgery patient presented back to the Post Graduate Prosthodontic clinic for uncovery of implant #22 and early loading of all the implants (Figure 6). Stability of all the implants was measured again using Osstell; the ISQ value of implant #19 was 67/64, implant #22 was 55/60, implant was #24 57/61, implant #27 was 65/68, and implant #30 was 69/65 indicating highly acceptable stability. Healing abutments were removed followed by the placement of the titanium temporary cylinders over the implant abutments. The patient's existing monolithic denture (Avadent-Scottsdale, Arizona) was early loaded and modified into a conversion prosthesis via the Balshi technique.<sup>10</sup> Radiographs were taken to confirm complete seating of the prosthesis. Occlusion was adjusted to have even contacts and no excursive interferences. The patient was instructed to avoid using the CPAP mask and was followed up 1 week after conversion to re-evaluate occlusion and mucosal healing around the conversion prosthesis and abutments.

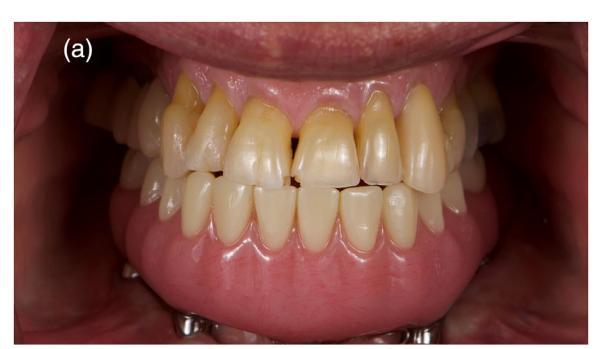
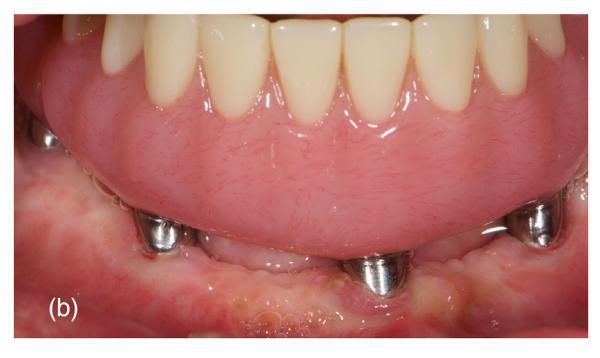
**FIGURE 7** (a) Intraoral view of definitive "Hybrid" Avadent Monolithic PMMA with robotically milled titanium framework and (b) Closeup intraoral view of prosthesis.

a robotically milled titanium bar. This monolithic PMMA is eight times stronger than traditional lab-processed PMMA (Balshi, S—ACP 2019 Annual Scientific Session).

The provisional prosthesis was removed. All abutments were torque tightened to 25 Ncm and ISQs were recorded. The hybrid prosthesis was screwed in and 15 Ncm torque was applied to prosthetic screws (manufacturer recommendation) after confirming complete seating on radiographs. Minor occlusal adjustments were made. Teflon tape was compressed into the screw access holes and Telio (Ivoclar Vivadent, Liechtenstein, Switzerland) was used to fill the screw access holes. The patient was delighted with the outcome of the treatment. The patient was put on a 4-month re-care. Post-treatment photos are shown in Figures 7–10.

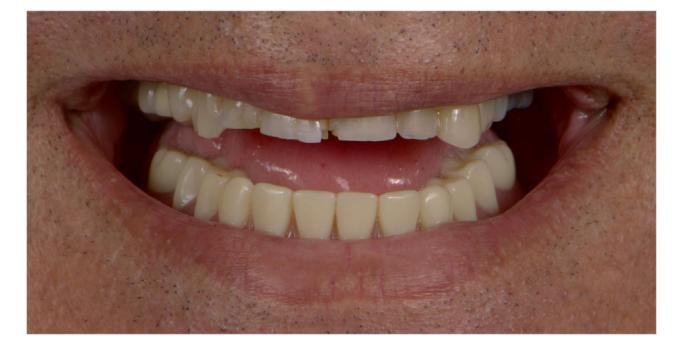
FIGURE 8 Close up smile of the definitive prosthesis in place.

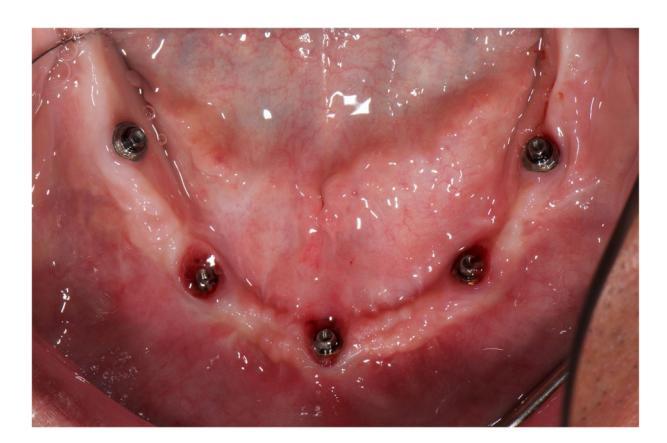
FIGURE 9 Occlusal view of healed mandibular arch.

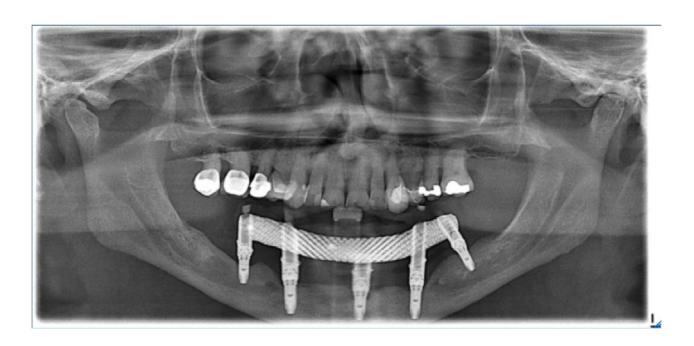
FIGURE 10 Panoramic: Definitive restoration.
