**Advanced Periodontitis Treated With Osseointegrated Implants**

*Thomas J. Balshi, D.D.S., F.A.C.P.*

## PROSTHODONTIC Insights

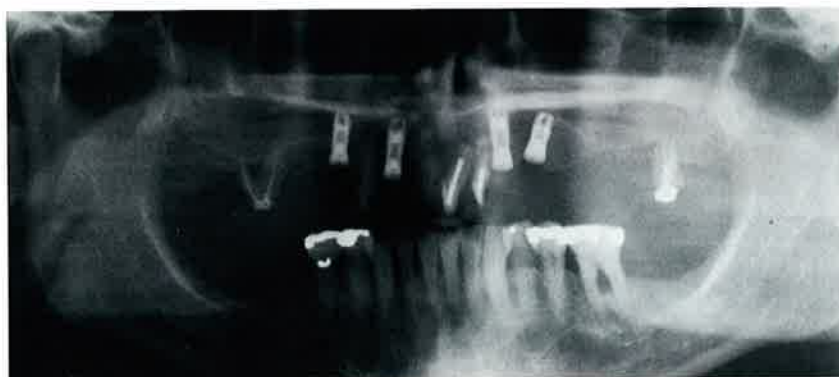
*Figure 3: Placement of four Brånemark titanium fixtures in the maxillary anterior. Note the available bone distal to the maxillary right terminal abutment.*

After much procrastination, in June of that same year the patient finally scheduled an appointment for fixture (implant) placement with a surgeon, unfortunately without the benefit of a guidestint nor in concert with the prosthodontic treatment plan. Four Brånemark implants were placed in the maxillary anterior (figure 3). Following the surgery the fixed provisional restoration required readaptation.

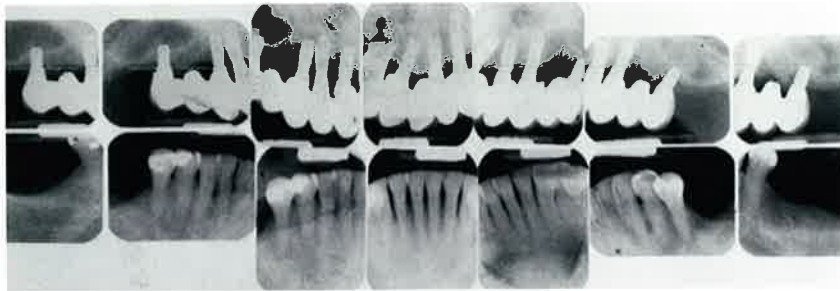
Figure 5b: Intraoral radiographs (11/90) clearly illustrate the fibrous encapsulation surrounding the most posterior fixture bilaterally (7 mm fixture.)

Approximately 1 1/2 years later (November 1990) the patient was reevaluated. Both 7mm fixtures had lost osseointegration and demonstrated a fibrous encapsulation.

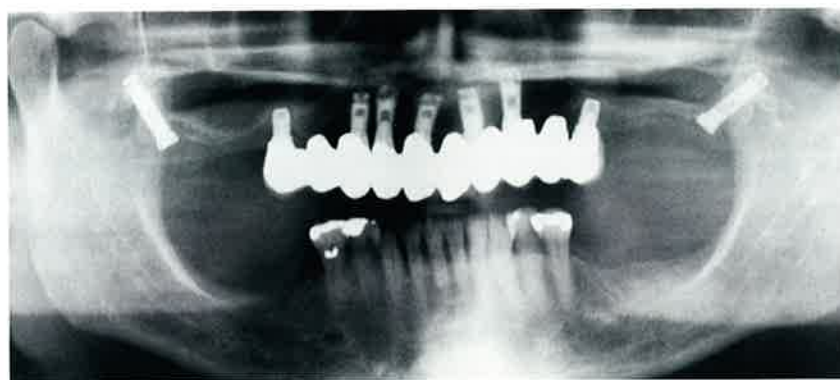
Figure 6: Panradiograph immediately following the maxillary pterygoid fixture installation November 1990. The 7mm fixtures continue to provide minimal support to the anterior prosthesis.

The patient now understood that removal of the 7mm fixtures would be required in order to avoid a posterior cantilevered situation. Placement of pterygomaxillary fixtures bilaterally were recommended and placed in November of 1990 (figure 6). The 7mm fixtures were allowed to remain in place until the new fixtures osseointegrated. In June 1991 the patient returned for second stage surgery, uncovering the pterygomaxillary fixtures. Both fixtures appeared stable. The existing 7mm fixtures were removed and the porcelain fused to gold tissue integrated prosthesis was modified with an extension bar obtaining support from the posterior fixtures (figure 7).
